## Cause and effect analysis of the degradation of the piston and cylindrical bushing in the engine supplied with diesel oil in the platform operated in the company vehicle fleet

KRZYSZTOF GARBBALA <sup>1</sup>, PIOTR CIBULKO <sup>2</sup>

**Keywords:** engine, motor vehicle, piston damage, cylinder damage

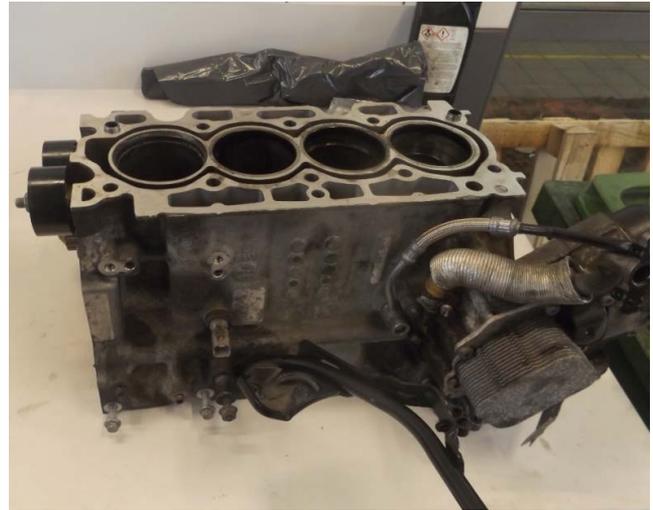
The engine block is shown in Figure 1. The organoleptic inspection of the condition did not reveal any visible cracks in the unit.

Figure 1 Motor block where fault occurred

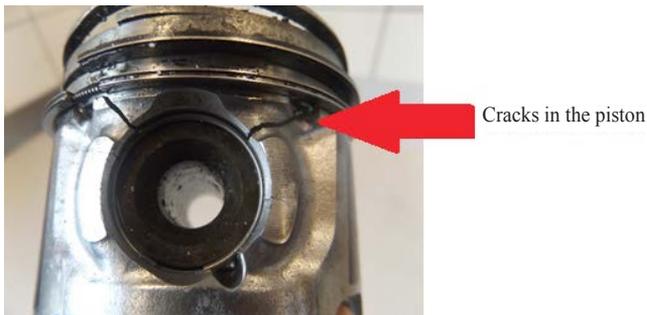
Figure 2 shows the piston that worked in the cylinder where the failure occurred.

The piston has numerous longitudinal and lateral cracks, which indicate high forces acting on the element during engine operation. The outer structure of the piston bottom shows numerous surface losses in the form of characteristic traces of impacts and fractures in its surface. These traces result from repeated contact between the piston head and metallic or foreign bodies. The piston also has a large amount of loss in the upper part. Such a loss had to be detached from the basic piston structure as a result of the action of high longitudinal force. The view of the piston bottom is shown in Figures 3 and 4. There are no signs confirming the operating conditions at elevated (degrading) temperature. Heat aggregating structures, such as piston edges or elements protruding over the plane of the piston head, do not exhibit overmelting in pistons operating at temperatures higher than those designed for this purpose.

**Figure 2** Piston that worked in the cylinder where the failure occurred

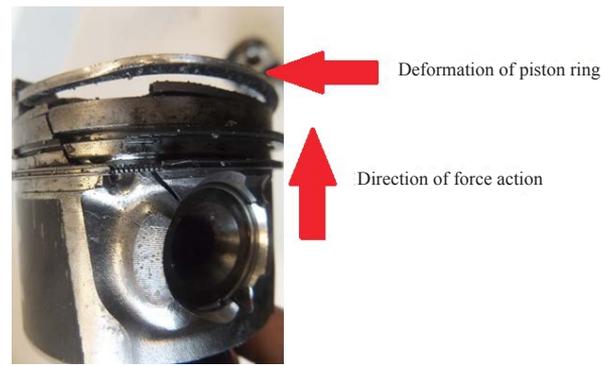
**Figure 5** Piston with deformed upper ring

The upper piston ring is characterized by the deformation of the shape caused by the influence of a large force acting in the upper-bottom axis of the piston operation. The occurring deformation of the ring exerted pressure on the upper part of the piston. This confirms the direction of bending of the ring. The ring exerted force on the upper part of the piston, causing its cracking and solidification of its parts into pieces. The broken piston pieces were located in the combustion chamber during engine operation. The piston with deformed upper ring is shown in Figure 5.

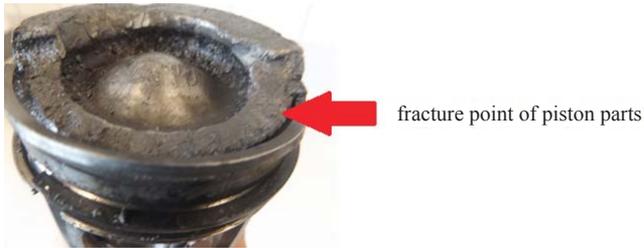
**Figure 3** Piston bottom surface

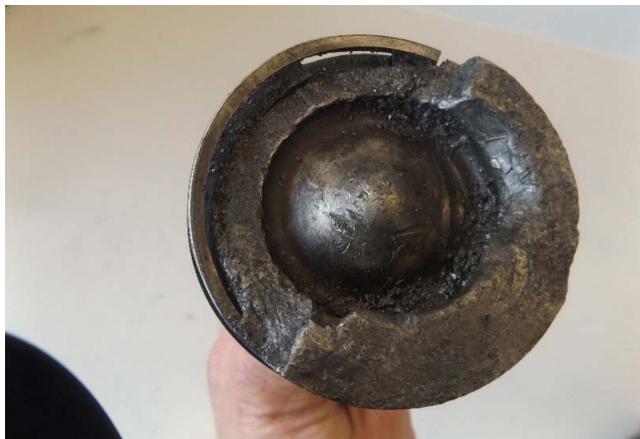
**Figure 4** Surface of the piston head (numerous losses in the surface are visible)

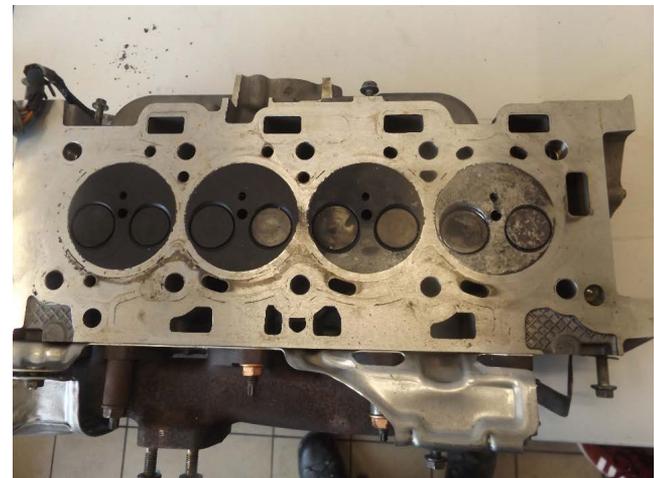
**Figure 6** Head presented for visual inspection

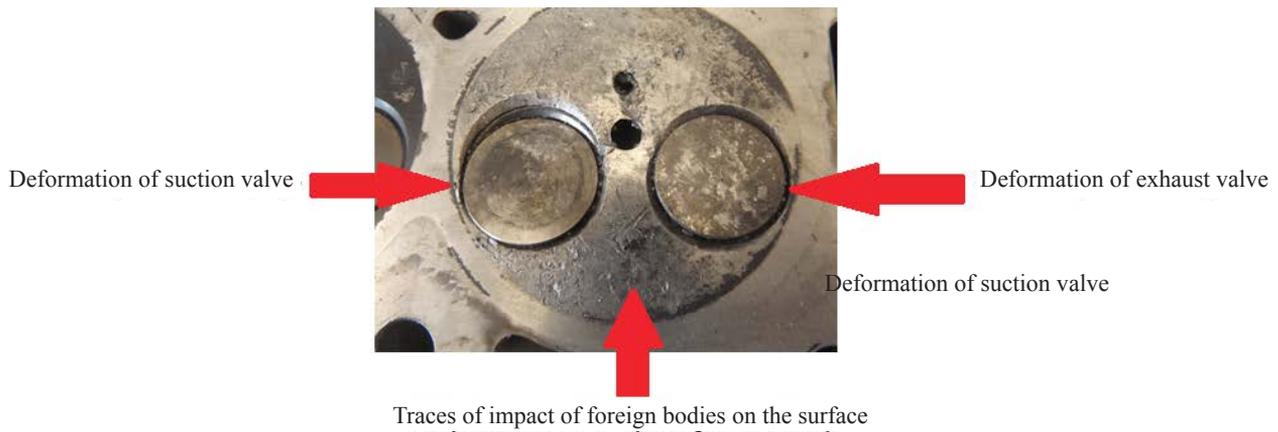
Figure 7 shows the area of the head adjacent to the cylinder where the failure occurred. There are signs of multiple metallic impacts of foreign bodies on this surface. In addition, the disc of the suction and exhaust valve in this cylinder is deformed. This condition of the valves prevents maintaining the tightness of the combustion chamber and proper operation of the combustion engine. The surfaces of the valve mushrooms also have numerous brushes, which indicate a large number of impacts of foreign bodies with high hardness. No traces of overmelting of the edges of valve sockets indicate the combustion temperature of the fuel and air mixture within the limits of the standard.

**Figure 7** Head surface over defective cylinder

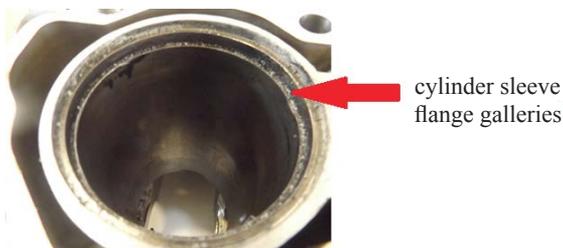
The cylindrical bushes of 3 cylinders show normal traces of operation. The cylinder cylinder sleeve where the failure occurred shows that there is no sleeve flange on which it was supported in the motor block. This flange was destroyed and its fragments were located in the combustion chamber during engine operation causing damage to the piston surface, valves and head. Additionally, the elements of the cylindrical bushing flange, as foreign bodies, were the cause of deformation of the inlet and outlet valve. The flange had to be destroyed as a result of heavy forces directed toward the bottom of the motor block. The broken flange cylindrical sleeve is shown in Figure 8.

**Figure 8** Cylinder bushing missing flange

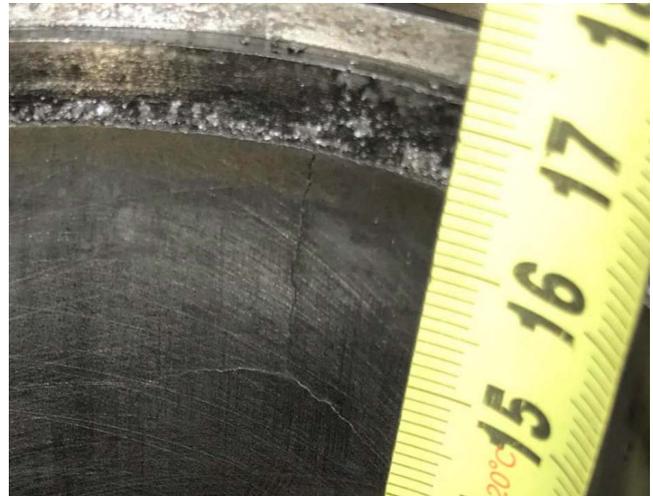
A lateral crack of about 32 mm length was observed on the surface of the cylindrical sleeve. This crack could be caused by the development of an internal microcrack during engine operation. An internal micro-crack may have occurred due to a cylinder sleeve striking on a hard surface (e.g. when falling from height) prior to its mounting to the engine block. This microcrack could also be caused by assembly errors, i.e. incorrect placement of the cylinder sleeve in the cylinder, or inaccurate cleaning of the cylinder lining before installation of the cylinder sleeve. The microcrack increased its size under the influence of

the motor operating temperature and vibrations, reaching at the critical operating moment of the motor a size of approx. 24 mm in width and approx. 32 cm in length, covering the flange which was damaged. The crack is shown in Figure 9.

**Figure 9** Cylinder sleeve cracking

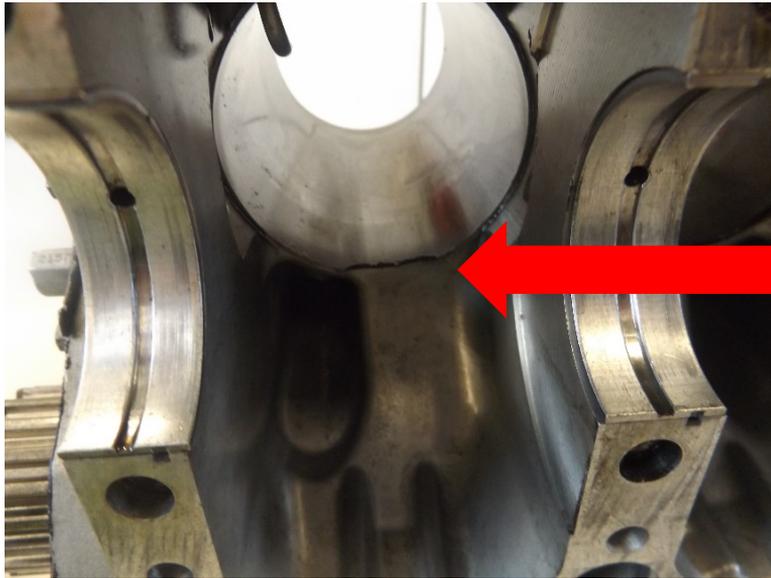
A significant reduction in the level of deposition of the cylinder sleeve in the cylinder where the failure occurred was also noticed. This is due to considerable force that pushed the bush down in the motor block while breaking its flange. In the lower part of the cylindrical sleeve a significant loss of cylindrical sleeve was observed. When the cylindrical bushing is displaced downwards in the cylinder, the crankshaft could break a part of the bushing hitting it. The loss of the cylindrical bushing is shown in Figure 10.

Loss of cylinder bushing

Figure 10 Loss at the bottom of the cylindrical sleeve
